INTERSTATE COMMERCE COMMISSION

INVESTIGATION NO. 2656

THE CHICAGO & NORTH WESTERN RAILWAY COMPANY

REPORT IN RE ACCIDENT

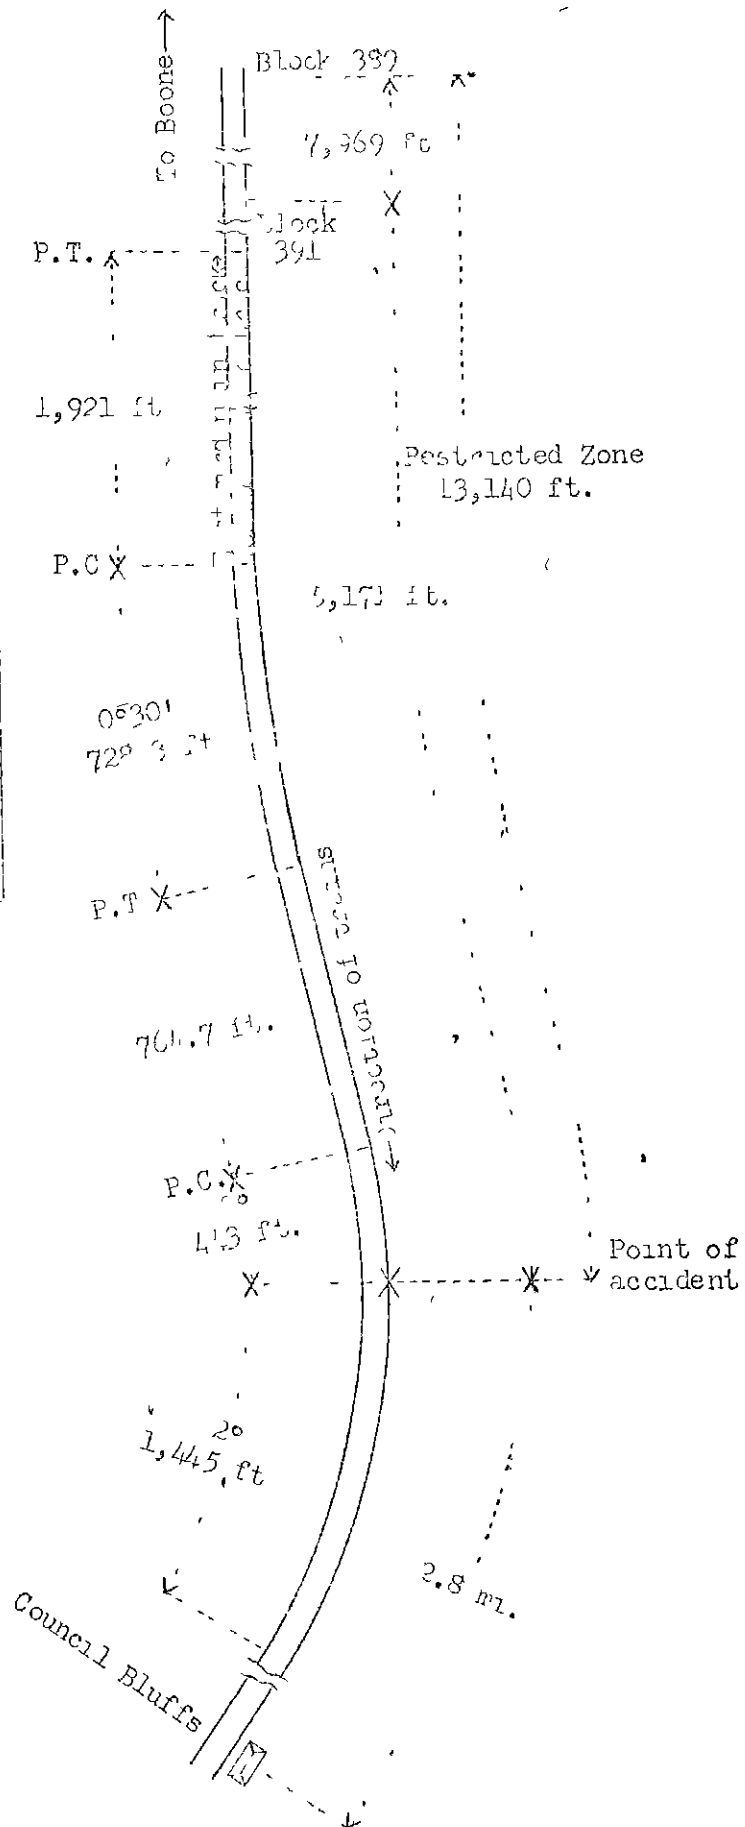
Location of Accident and Method of Operation

Inv. No. 2639
Chicago & North Western Railway
Council Bluffs, Iowa
October 2, 1942
